Ca' Foscari
University
of Venice

Final Thesis

Investigation of the rising damp phenomenon in
historical Venetian buildings by a new multi-
analytical approach

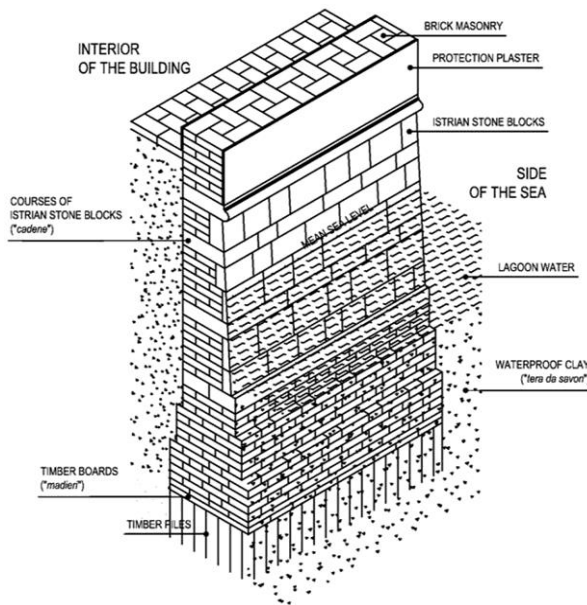
Figure 6 Schema of Venetian building foundations both interior and on the sea side [21].

Considering all these implications, Venice has a specific and unique construction system. As well known, the city was build on soft, silt and clay based soil in which a wooden piles system was embedded till reaching the underlying harder soil (*caranto*) [24] (Figure 6).

All these elements constituted foundation itself. This latter corresponds to a plinth wall, with sloping walls and brick or Istria stone blocks [25]. Considering the wooden piles in water, normally these would have rotted in time. Nevertheless they were made in oak or larch, two wooden species highly water resistant but equally destined to rot over time. Since the wooden piles are underwater and so in an anaerobic environment, timber rot was thought to be impossible [21]. On the contrary, a study on the wooden foundations of Venice proved a slow timber rot in time [26] despite piles are additionally protected by the high amount of silt and silt clay sediment constantly driven by water and so absorbed by the wood increasing its hardness [21].

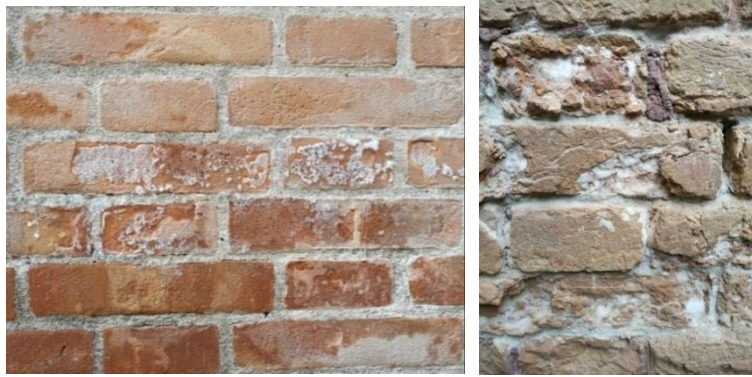
Figure 3 Efflorescence on Venetian masonries. Photos taken on the 25th November 2019 in Sestiere Castello.

- *Efflorescence* occurs in dry and calm air [41] due to the temperature difference between the internal and the external part of a building. The internal part is hotter (especially in winter) and this forces the moisture towards the external part of the masonries. Once the exterior wall is reached, the temperature change causes the moisture evaporation and consequently the salt crystals deposition. These in general are clearly visible as white masses on the bricks surface (Figure 7) often in the form of powder.

Despite efflorescence is usually considered less harmful than subflorescence, the former indicates the presence of the latter and can affect the coherence, endurance of bricks and create spalling of their surfaces [21].

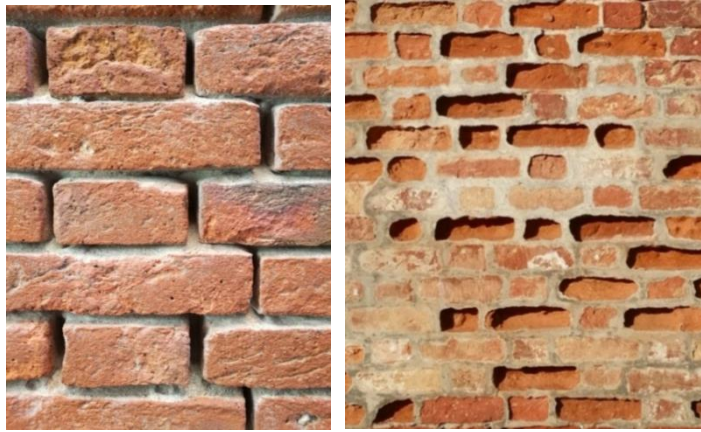
Figure 8 Examples of bricks and bedding mortar decays: a) bedding mortar loss and bricks quite undamaged; b) Advanced brick deterioration and losses, bedding mortar less damaged. Photos taken in Venice on the 25th November 2019 in Dorsoduro

In masonry, bedding mortar enhances mechanical cohesion among bricks, increasing the total wall resistance and the uniform distribution of the weight structure. Different binders have been applied through the time, firstly mortar but since XIX century also the Portland cement. As like as river sand was applied until XV-XVI century and then cocchiopesto was introduced in the masonry construction. At the same way also binder/aggregate ratio is variable [25]. A scarce bedding mortar- brick interaction enhances water penetration in voids of the surface contact between the two materials and material losses (Figure 8). In the worst cases, if bearing walls are involved, a reduced weight resistance of masonry is enhanced. In this way also the masonry resistance to freeze-thaw and crystallization cycles is compromised [44].

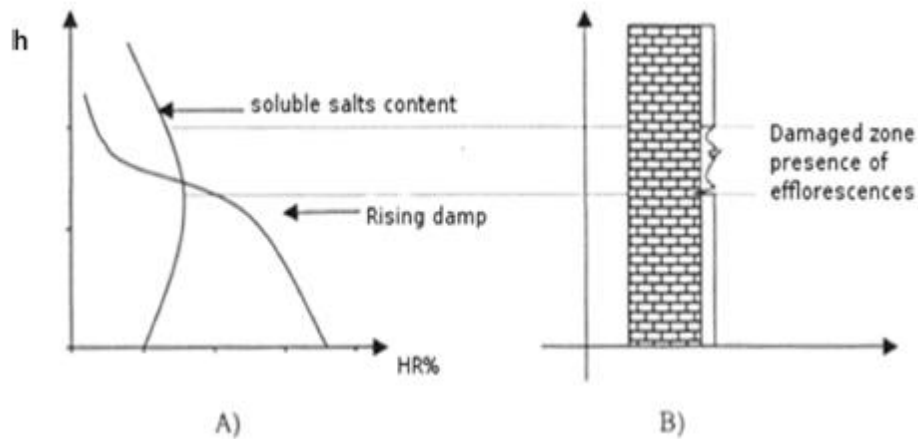
Figure 9 Empirical model proper of rising damp in Venetian walls: A) SS% and MC% curves distributions based on experimental measurements ;B) rising damp and salts damaging action on masonry [38].

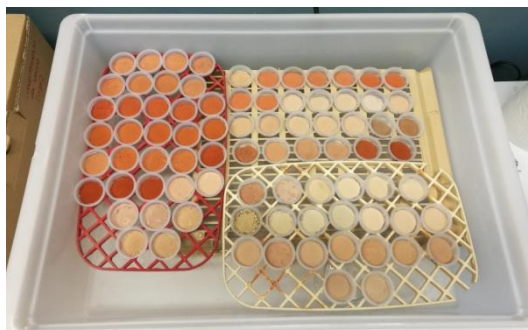
Figure 19 The 82 brick powder samples weighted and put into a box with the underlying saturated solution of KCl.

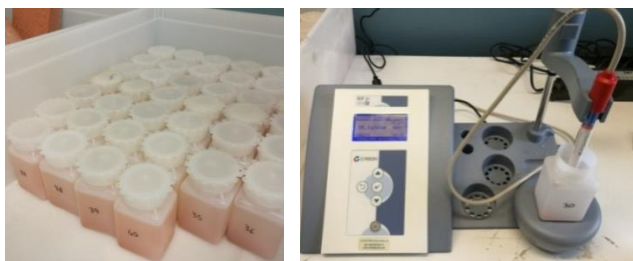
Figure 20 Sample solutions (left) and their conductivity measurements (right): conductometer and conductivity cell used.

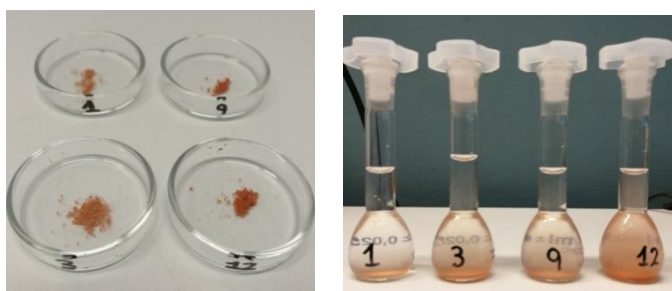
Figure 21 Preparation of the Ion Chromatography solutions: the powders were weighted (left) and brought up to volume with milliQ water in volumetric flasks

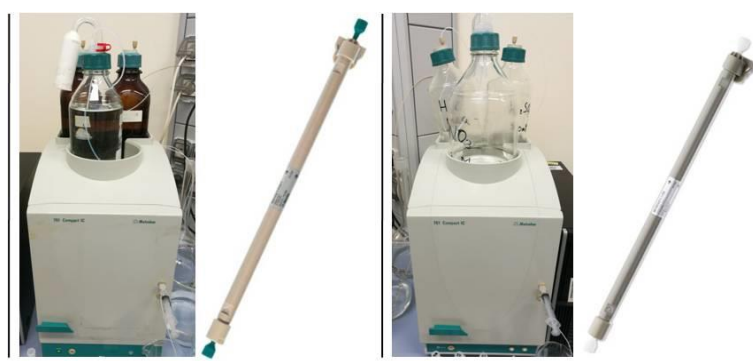
Figure 22 Chromatographs and column used for the anions (left) and cations (right) detection [82].

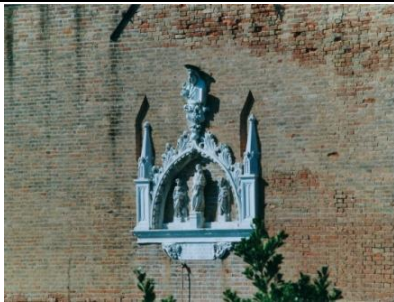
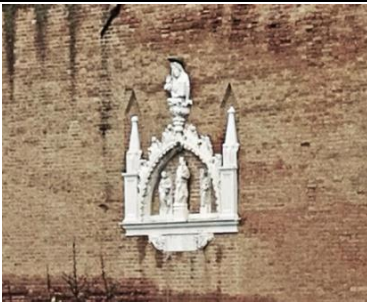
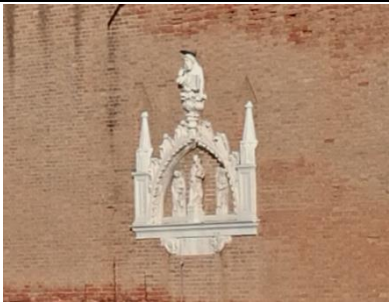
Location Name	Altimetry (cm on m.s.l.)	Old Photo	Current Photos		Comparison Scale /Comments
98 Rio delle Vergini. Resto di portale gotico ed iscrizioni	0

<p data-bbox="1391 584 1565 608">Date: 25-11-2019</p>	<p data-bbox="1731 363 2056 499">Rising damp trend (lower part): + Biological growth: / Plaster loss: / Efflorescence: / Brick erosion: /</p>
1852 Rio de la Tana Arsenale-Canevo. Torre angolare col rio de S. Daniel	0

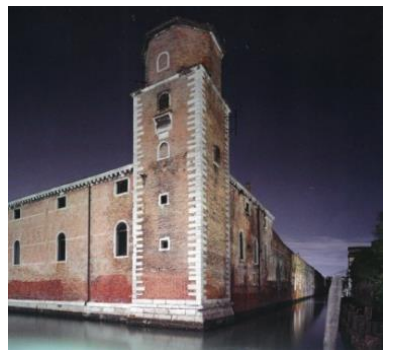
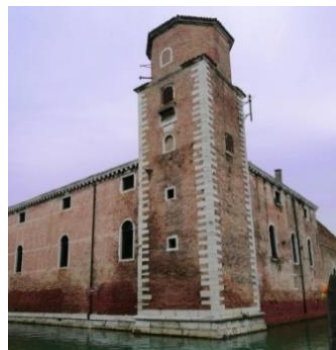
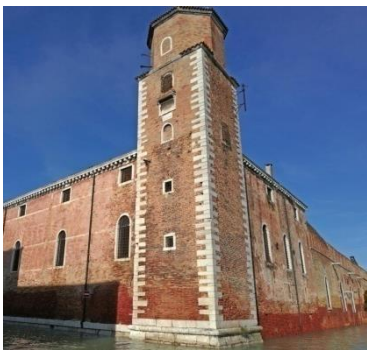
<p data-bbox="1391 994 1565 1018">Date: 25-11-2019</p>	<p data-bbox="1731 735 2056 898">Rising damp trend (left part of the tower): = Biological growth: / Plaster loss: / Efflorescence: / Brick erosion: /</p>
2427 A Rio de le Gorne	0

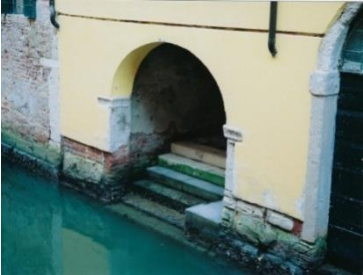
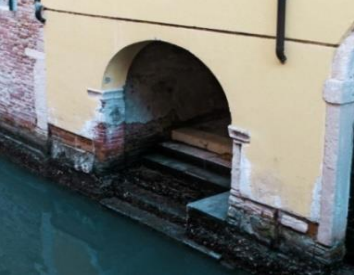
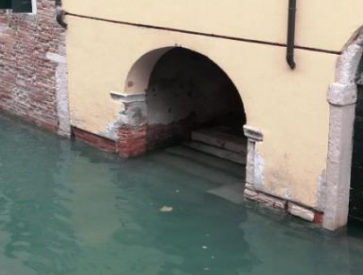
<p>2641 Rio de S. Martin (con ingresso in Calle de l' Arco)</p>	<p>0</p>

<p>Date: 16-11-2019</p>	<p>Rising damp trend: - Biological growth: + Plaster loss: + Efflorescence: - Brick erosion: +</p>
<p>2654 Rio dei Scudi con ingresso in calle dei Scudi Ca' Venier. Portale da acqua</p>	<p>0</p>

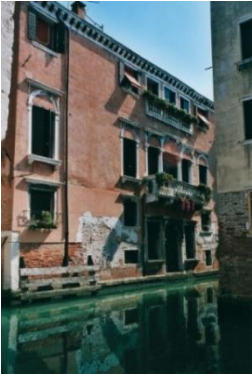
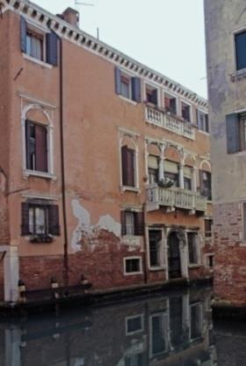
<p>Date: 26-10-2019</p>	  <p>Date: 16-11-2019</p>	<p>Rising damp trend: ++ Biological growth: = Plaster loss: ++ Efflorescence: - Brick erosion: +</p>

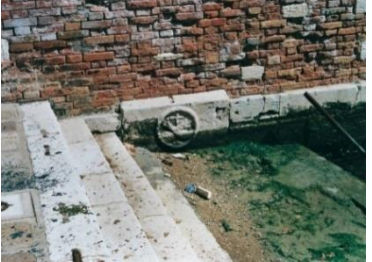
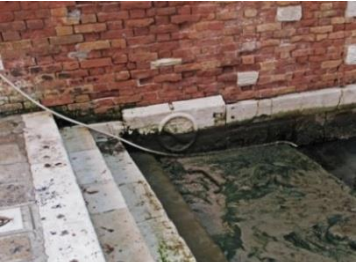
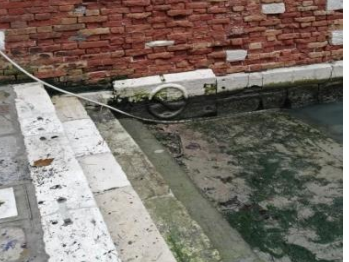
<p>2784 Campo de la chiesa (San Francesco della Vigna) Simbolo religioso</p>	<p>0</p>

<p>Date: 16-11-2019</p>	<p>Rising damp trend: ++ Biological growth (visible on the religious symbol) : ++ Plaster loss: / Efflorescence: - Brick erosion: =</p>
<p>3207 Rio dei Scudi con ingresso da terra in ramo de le Gatte</p>	<p>0</p>	  <p>Date: /</p>	  <p>Date: 26-10-2019</p>

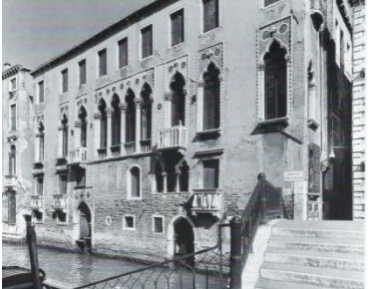
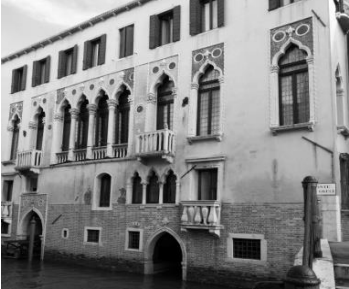
<p>Date: 16-11-2019</p>	<p>Rising damp trend: ++ Biological growth: / Plaster loss: / Efflorescence: / Brick erosion: /</p>

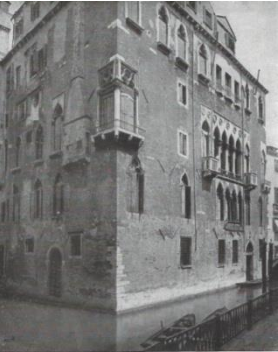
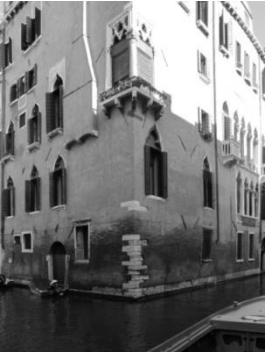
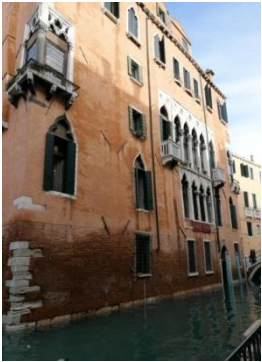
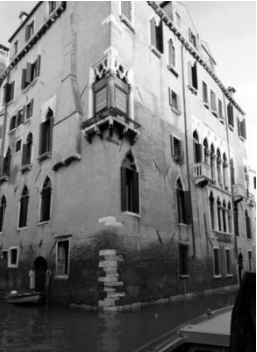
<p>Date: 16-11-2019</p>	<p>Rising damp trend: +++ Biological growth: = Plaster loss: = Efflorescence: - (probably due to the more wet wall of the current photos) Brick erosion: =</p>

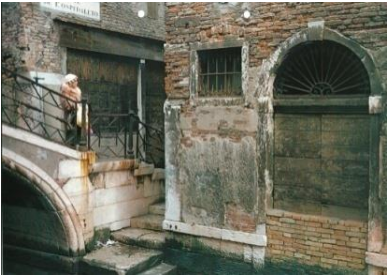
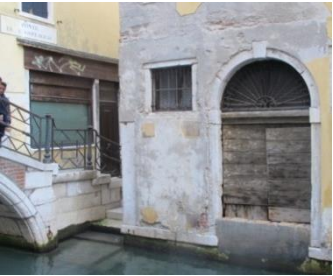
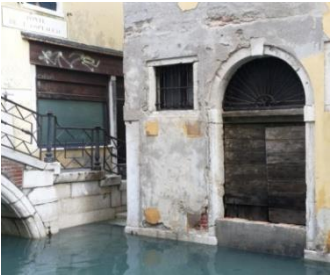
<p>6377 Ponte de l' Ospealeto (foto rivista)</p>	<p>0</p>

<p>Data: 16-11-2019</p>	<p>Rising damp trend: = Biological growth: + Plaster loss: - Efflorescence: / Brick erosion: /</p> <p>The whole wall has been covered with plaster.</p>
<p>6378 Fondamenta al ponte de la Tetta- Rio di S. Giovanni in Laterano</p>	<p>0</p>

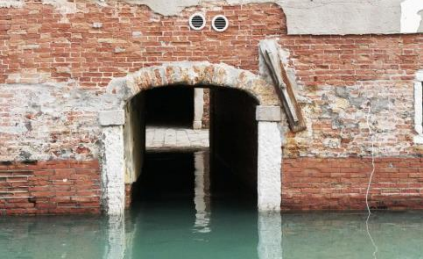
<p>2927 Rio de Santa Margherita-Riva de acqua</p>	<p>0</p>	  <p>Date: /</p>

<p>Date: 26-11-2019</p>	<p>Rising damp trend: = Biological growth: = Plaster loss: - Efflorescence: - - - Brick erosion: +</p> <p>Two ventilation grills and plaster have been added over time in the upper part but, as visible in current photos, it is already damaged and plaster losses are visible.</p>
<p>2946 Rio di Santa Margherita-Sotoportego de l' uva quattro finestrelle</p>	<p>0</p>

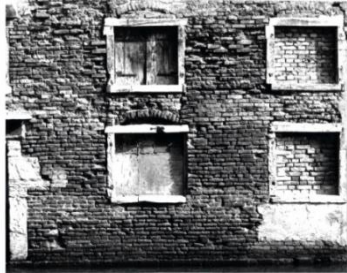
<p>Date: /</p>	  <p>Date: 18-11-19</p>	  <p>Date: 26-11-2019</p>	<p>Rising damp trend: + + Biological growth: / Plaster loss: / Efflorescence: / Brick erosion: -</p> <p>The wall has been restored, bricks have been replaced and two metallic elements have been added in the upper part.</p>
<p>3228 Palazzo Giustinian</p>	<p>0</p>	  <p>Date: /</p>

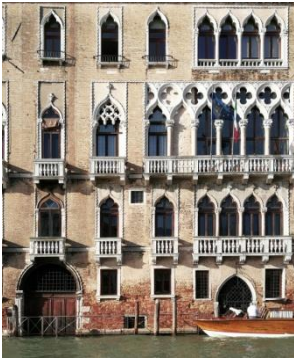
<p>Date: 25-11-2019</p>		<p>Rising damp trend: + Biological growth: + Plaster loss: / Efflorescence: / Brick erosion: /</p>

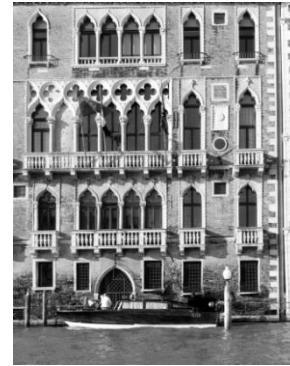
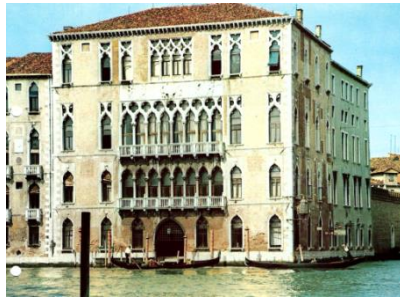
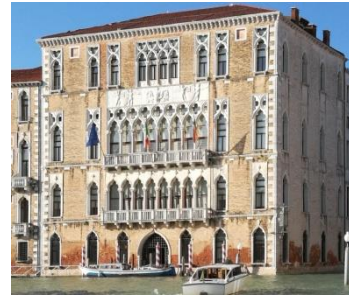
3246
Calle Foscari-
Ca' Foscari

Rising damp trend: =
Biological growth: /
Plaster loss: /
Efflorescence: /
Brick erosion: /

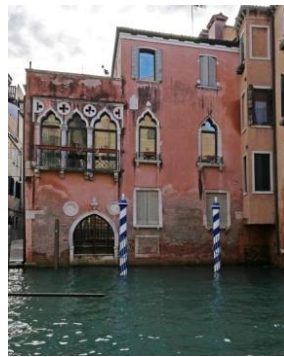
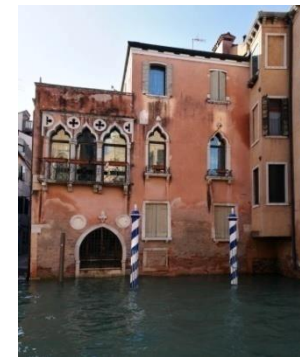
The plaster has been
replaced over time but there
are visible losses in the
current one.

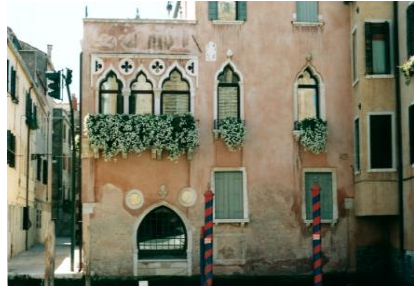
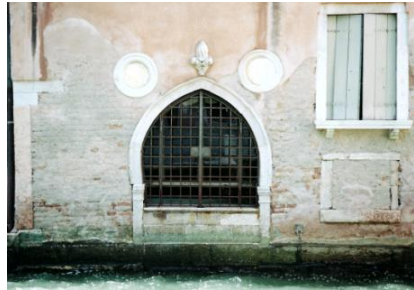
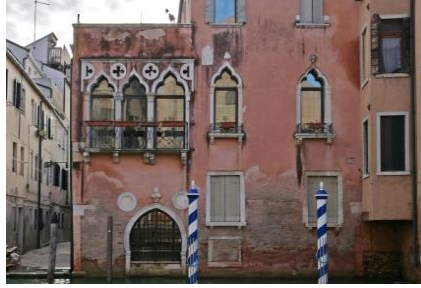
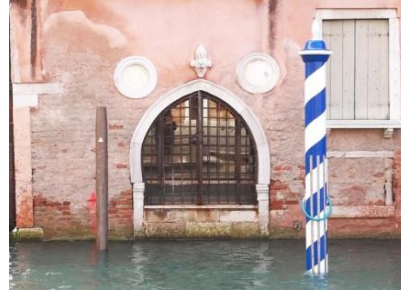
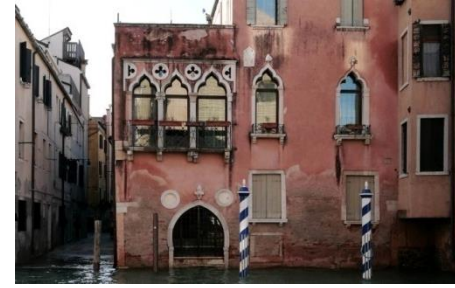
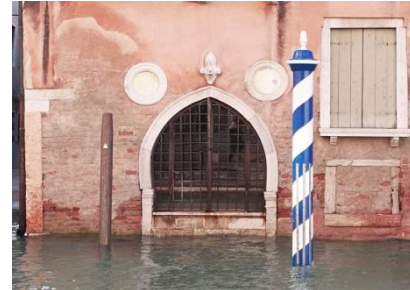
Rising damp trend: ++
 Biological growth: +
 Plaster loss: ++
 Efflorescence: =
 Brick erosion: +

The wooden poles have been modified or replaced over time.

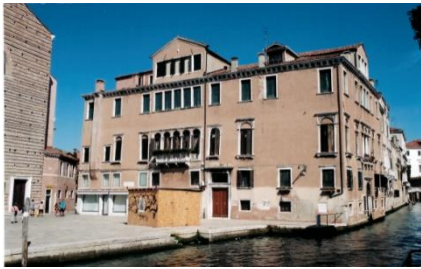
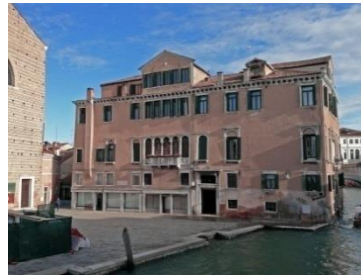
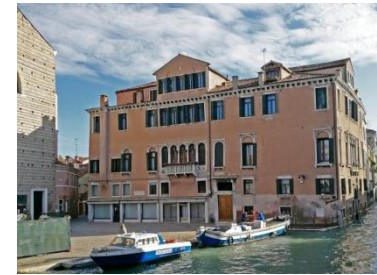
3707
 Campo San
 Pantalon- Ca'
 Signolo-
 Loredan

Rising damp trend: =
 Biological growth: /
 Plaster loss: +
 Efflorescence: /
 Brick erosion: /

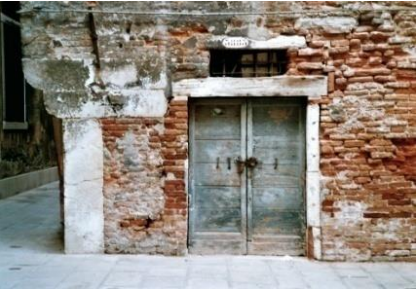
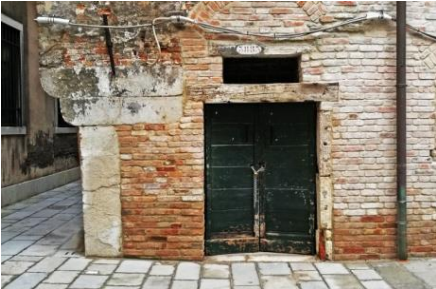
<p>3885 Corte Marcona- Barbacani e porta di magazzino</p>	<p>119-124</p>

<p>Date: 26-11-2019</p>	<p>Rising damp trend: + Biological growth: - Plaster loss: = Efflorescence: - Brick erosion: +</p> <p>The wall has been restored, bricks replaced and the wooden edges of the door, which in the old photo are white painted, lost the colour.</p>
<p>3423 Corte del Fontego Resti di porticato bizantino</p>	<p>137-141</p>

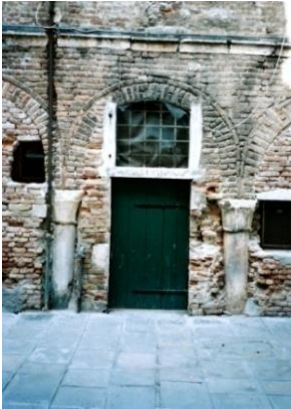
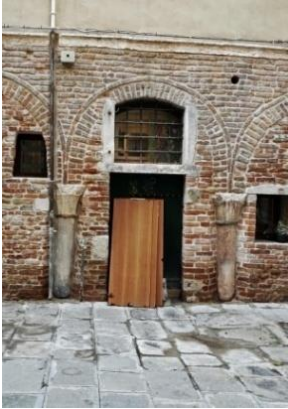
<p>Date: 26-11-2019</p>	<p>Rising damp trend: + Biological growth: - Plaster loss: - Efflorescence: - Brick erosion: +</p> <p>The wall has been restored and bricks replaced, especially in the lower part. A cleaning intervention is clearly visible in the upper part of the masonry. A hole in the right area of the wall is present in the current photos.</p>

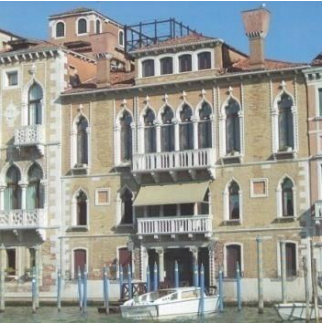
<p>2307 Campiello Contarini Ca' Contarini</p>	<p>0</p>	  <p>Date: /</p>

<p>Date: /</p>	  <p>Date: 26-06-2019</p>   <p>Date: 26-06-2019</p>	  <p>Date: 26-11-2019</p>   <p>Data: 26-11-2019</p>	<p>Rising damp trend: = Biological growth: = Plaster loss: = Efflorescence: - Brick erosion: +</p> <p>The comparison is quite difficult due to the high distance from the building. However the rising damp level seems to be the same between the old photo and the current ones.</p>
<p>2432 Portale ad acqua (Rio de le Ostreghe)</p>	<p>0</p>	  <p>Date: 2007</p>	  <p>Date: 26-06-2019</p>	  <p>Date: 26-11-2019</p>	<p>Rising damp trend: + Biological growth: = Plaster loss: / Efflorescence: - Brick erosion: +</p> <p>In the current photo of June a wide round zone in the left part of the wall is visibile. The same area is found in the photo of November despite the evidently wetter wall.</p>

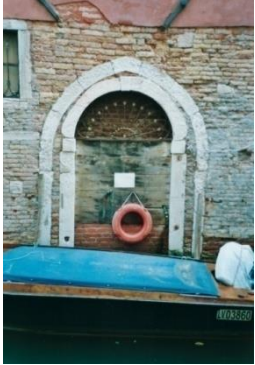
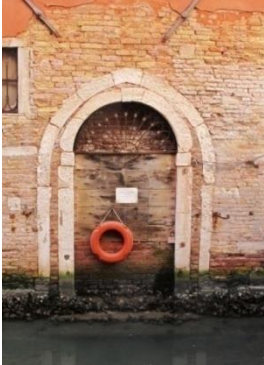
<p>2513 Rio de San Maurizio- Ca' Malipieri Porta ad acqua</p>	<p>0</p>

<p>Date: 26-11-2019</p>	<p>Rising damp trend: + Biological growth: = Plaster loss: ++ Efflorescence: + Brick erosion: +</p> <p>The comparison is not so easy due to the boat covering the lower zone. Also the different light conditions between the two current photos make more difficult an obvious comparison.</p>
<p>2517 Rio Santa Maria del Giglio Portale murato</p>	<p>0</p>

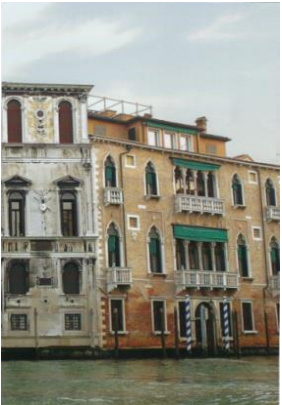
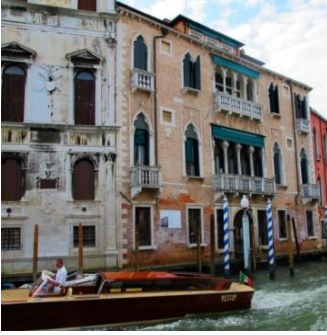
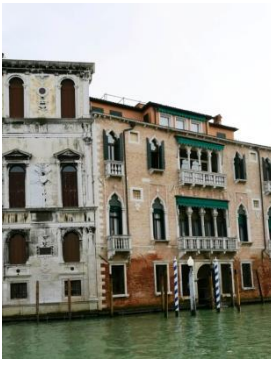
<p>3319 Ca' Erizzo- Nani Mocenigo</p>	<p>0</p>

<p>Date: 26-11-2019</p>	<p>Rising damp trend: + Biological growth: / Plaster loss: / Efflorescence: ++ Brick erosion: +</p>
<p>3421 A Rio de Ca' Garzoni</p>	<p>0</p>

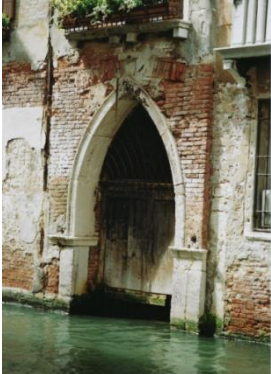
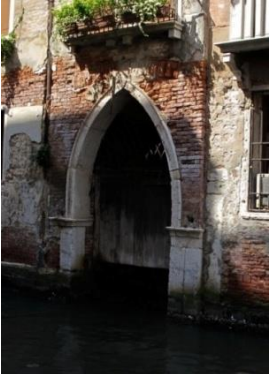
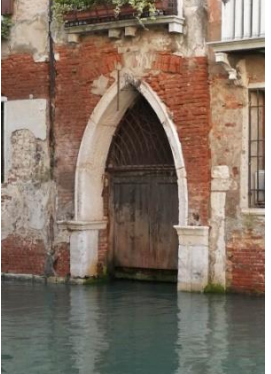
<p>Date: 26-11-2019</p>	<p>Rising damp trend: + Biological growth: + Plaster loss: + Efflorescence: - Brick erosion: +</p>

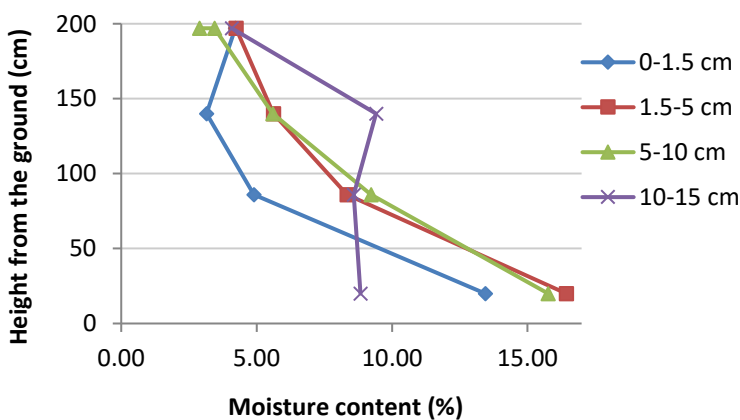
Moreover the decreasing trend is the same at all depths except for the 10-15 cm one (purple line in Figure 32). In fact at this depth and at 140 cm the MC% is higher than that measured at the lower height of 20 cm.

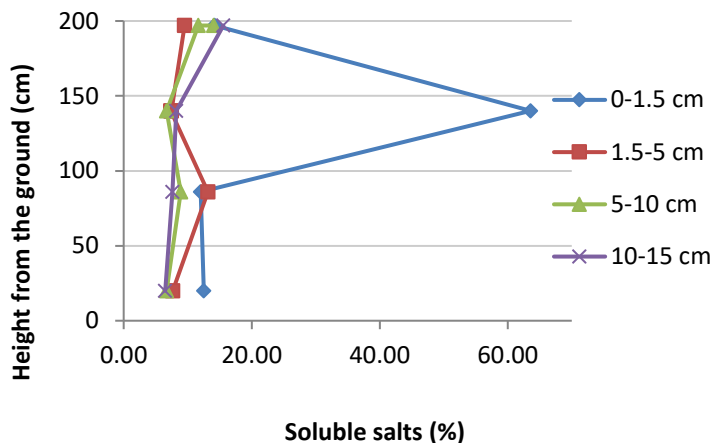
Figure 33 Soluble salt content % trend with respect to height and depth of Ca' Foscari wall.

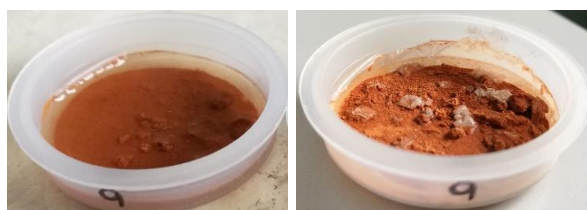
Figure 34 The formation of the water layer and subsequently of the salt crystals for the sample at 140 cm height and 0-

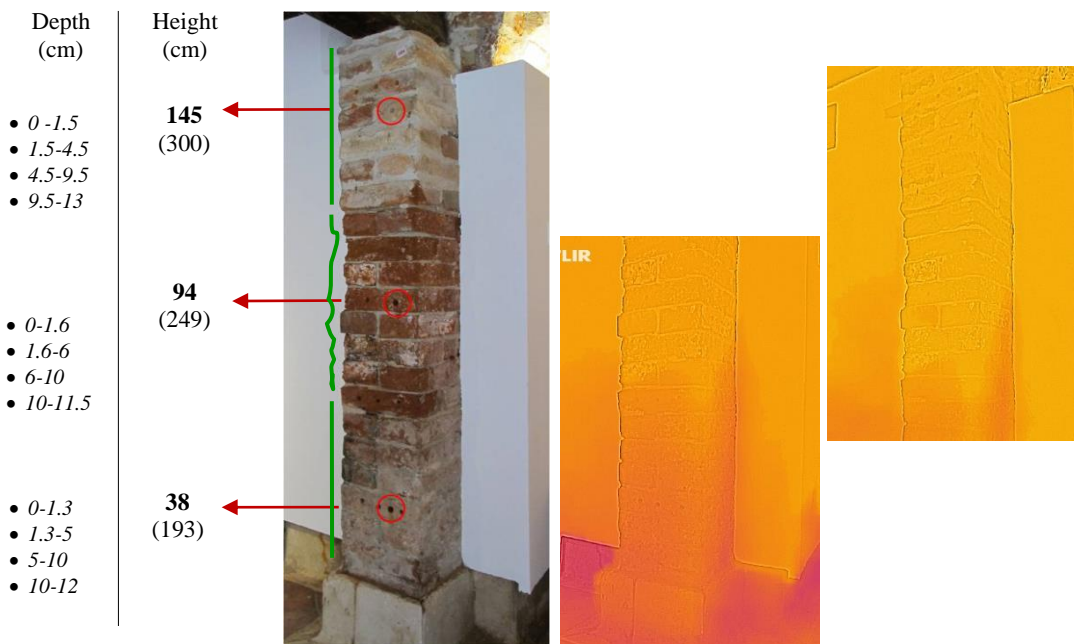
Figure 35 Visible light and infrared photos of the masonry pillar in Ca' Bottacin. Depths and heights of samplings are specified as also the height on m.s.l. in brackets. The green lines show the damaged bricks with an irregular profile in the middle area. The temperature scale of colours for IR thermography photos is between 20.8 °C (purple) and 25.2 °C (yellow)

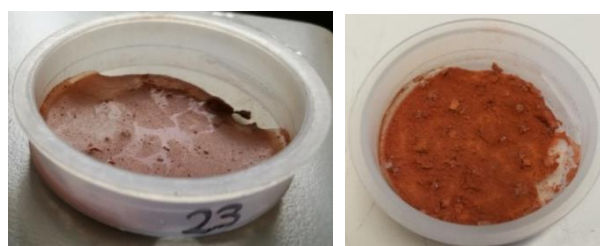
Figure 36 Formation of the water layer on powder sample 23 (left) and subsequently salts formation (right). The crystal salts are lesser visible with respect to the Ca' Foscari case in Figure 34.

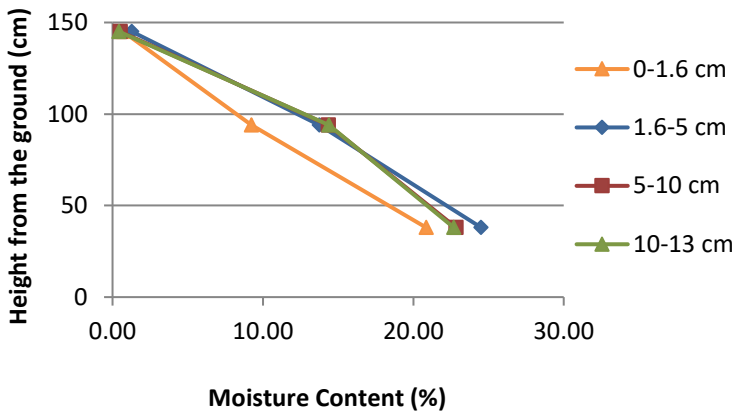
Figure 37 MC % trend with respect to height and depth for Ca' Bottacin wall

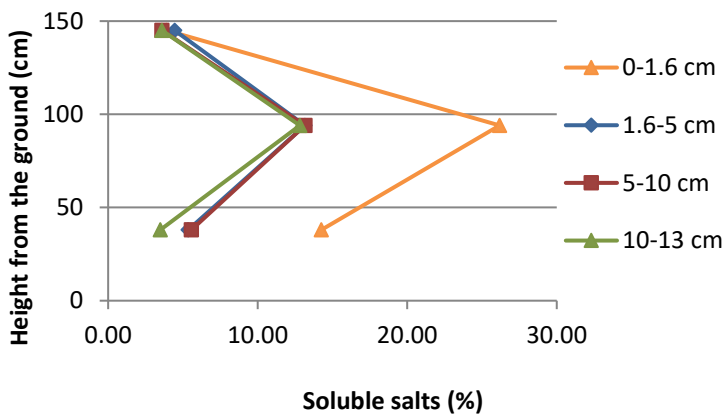
Figure 38 Soluble salts % with respect to samples height and depth for Ca' Bottacin wall.

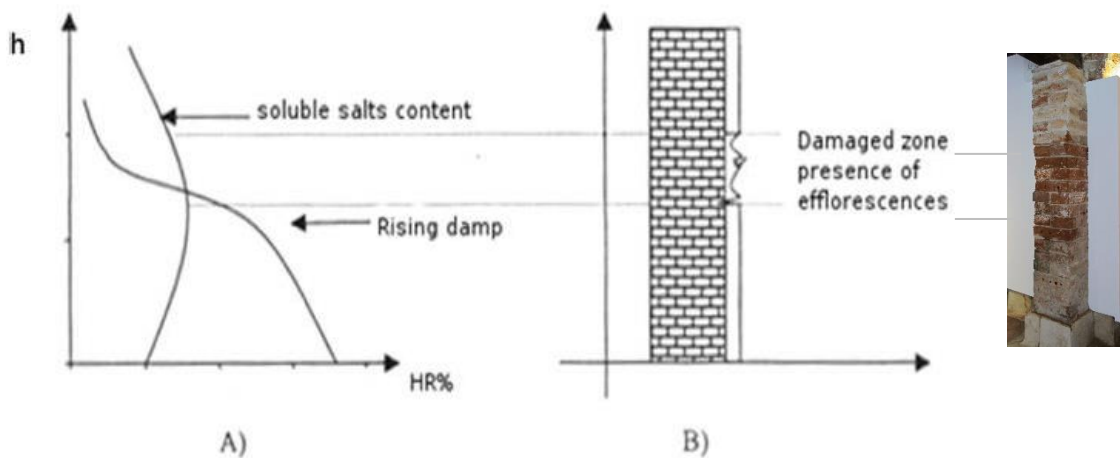
Figure 39 Relationship between Ca' Bottacin pillar and empirical model for rising damp in Venice. The evaporation area corresponds to the maximum salt concentration and so maximum damage on masonry [38]

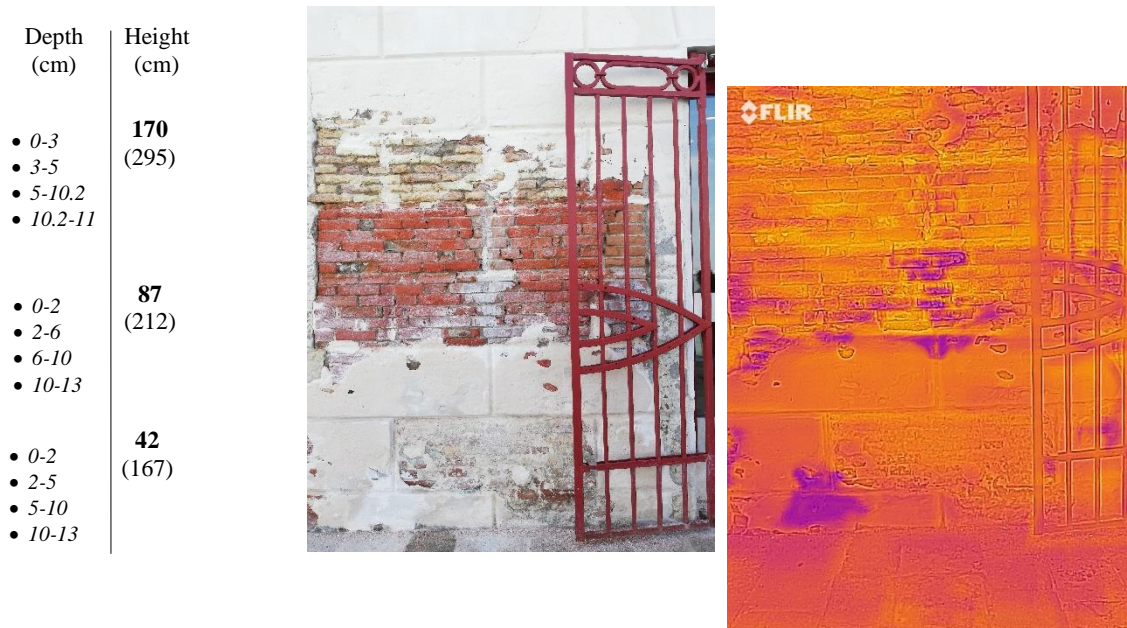
Figure 40 Ex Slaughterhouse San Giobbe masonry in visible and infrared light. The infrared colour scale covers the temperature range between 20-25 °C. Infrared image is shifted with respect to the other one in order to facilitate the comparison by aligning the respective masonry morphological details.

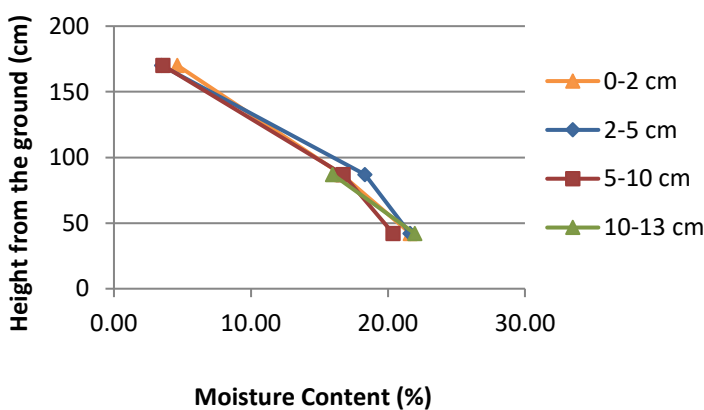
MC% trend for San Giobbe is homogeneous at all masonry depths. Values around 20-22% characterize the lower part of the wall (42 cm height); 16-18 % range was found at middle height (87cm) and 3-4% corresponds to the highest wall area (Figure 41)

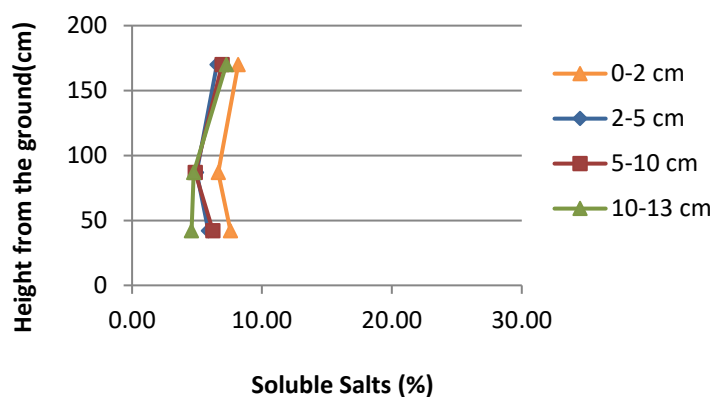
The graphical homogeneity for MC% at all depths is found also for SS% (Figure 42). The only exception is the external wall surface (0-2 cm depth) for which the highest salt content is measured (8.17%). On the contrary, the lower SS% is around 5% at 87 cm height.

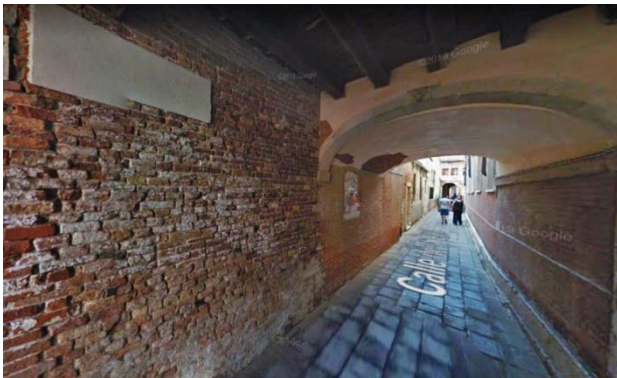
Figure 43 Sotoportego de la Laca with the sampled masonry on the left. The wall is protected by the upper structure. Image taken from Stretview by Google.

Badoer Palace wall is located in *Sotoportego de la Laca* and so quite protected from rainfall and wind, the same cannot be said for San Giobbe masonry without any protection and so directly exposed to weathering. The Badoer Palace sampling site has an altimetry of +102 cm on m.s.l. with respect to Punta della Salute.

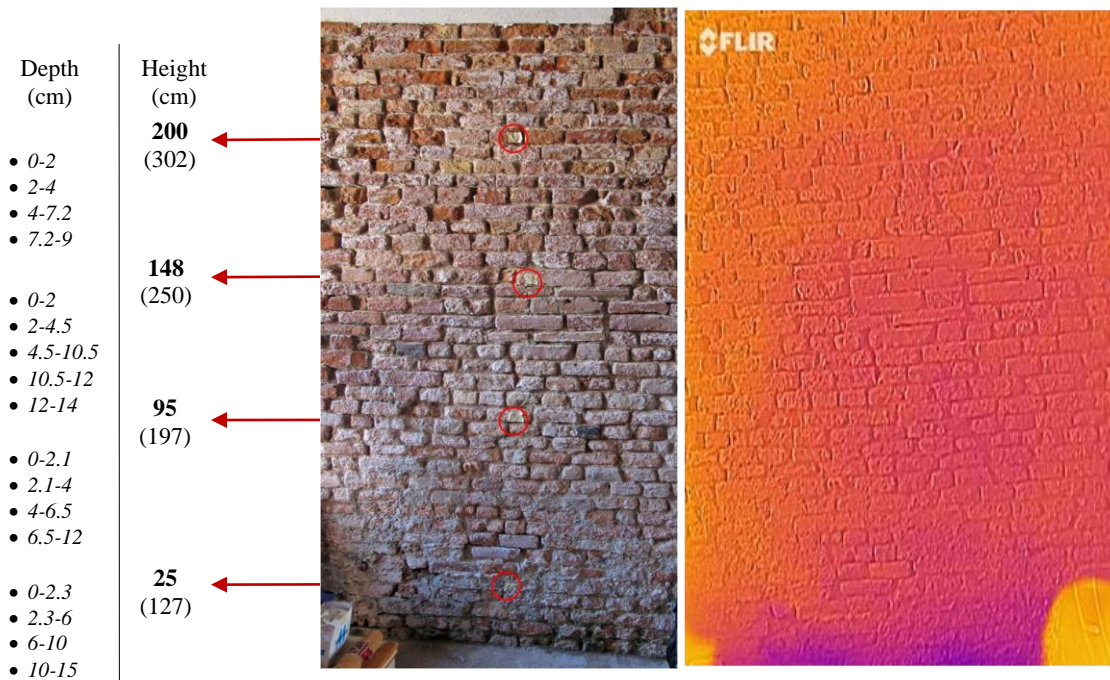
Figure 44 The external masonry of Badoer Palace in visible light with the chosen sampling points. Height and depth of the samplings are specified, as like as their height on the m.s.l. in brackets. The colour scale for the infrared photo is comprised between 19.4-22.9 °C

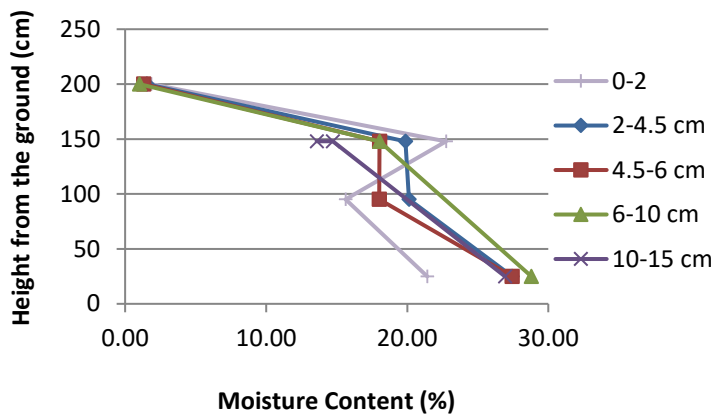
Figure 44 Moisture Content % at each height and depth for Badoer Palace masonry.

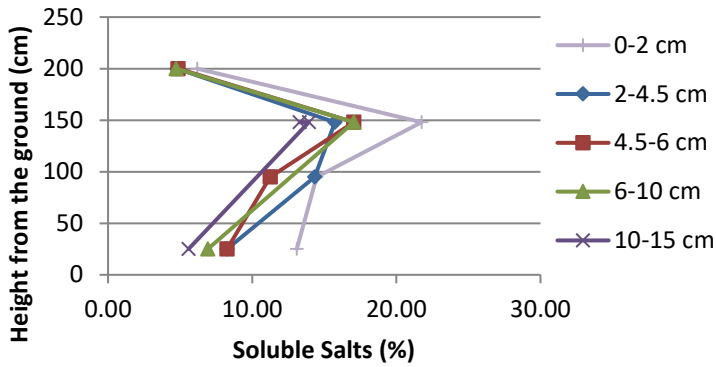
Figure 45 Soluble salt distribution for each sampling depth and depth at Badoer Palace.

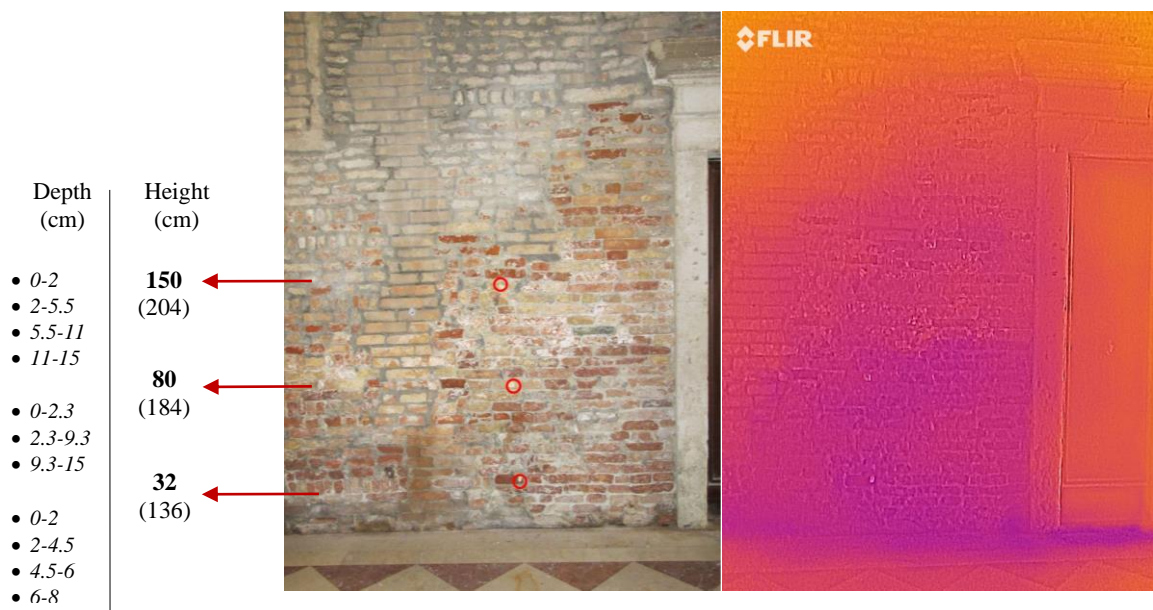
Figure 46 Ca' Tron masonry in visible light and in infrared thermography. The sampling points, with related height and depth are indicated. The infrared photo covers the degree range between 20.6 and 23.4. Heights on m.s.l. are reported in brackets.

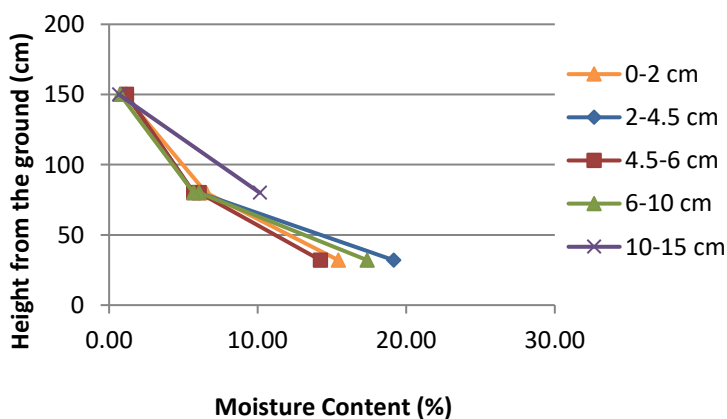
Figure 47 MC % distribution according height and depth in the Ca' Tron wall.

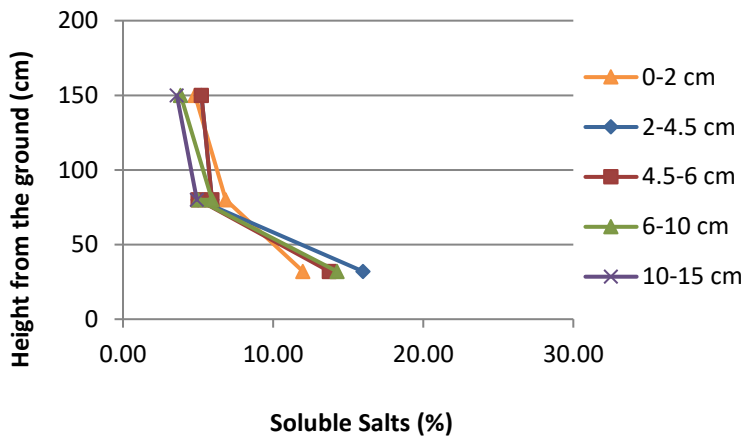
Figure 48 SS content distribution according heights and depths of Ca' Tron wall.

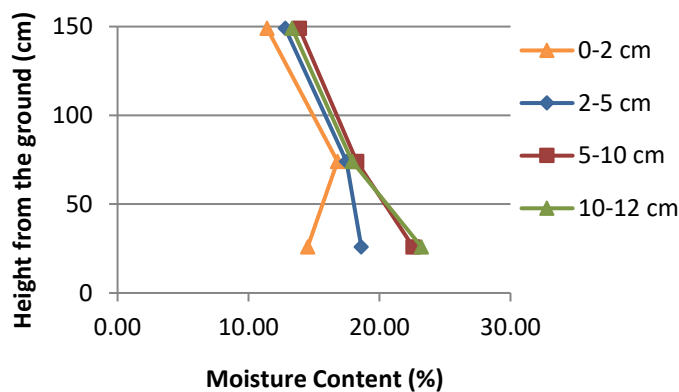
Despite not so high MC% differences were measured, the highest values are those of the middle zone (74 cm) and the lower one (26 cm). Here MC values increase at increasing depths. At the 149 cm MC is around 11-13%, the lowest registered percentages (Figure 50).

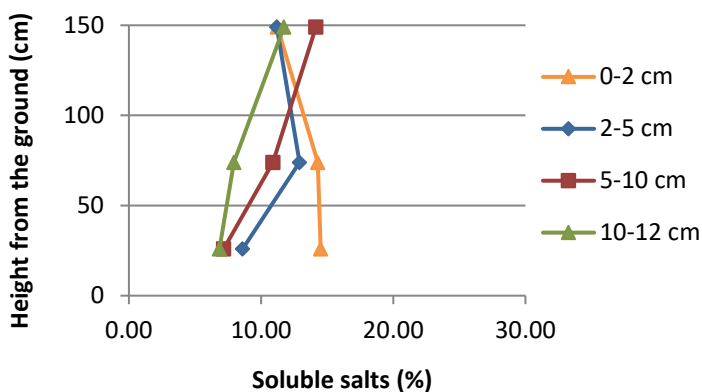
The wall salt content is higher at 149 cm height (11-14%), especially at 5-10 cm depth. At the lower height of 26 cm and 0-2 cm depth has a higher salt content than the other considered depths (Figure 51).

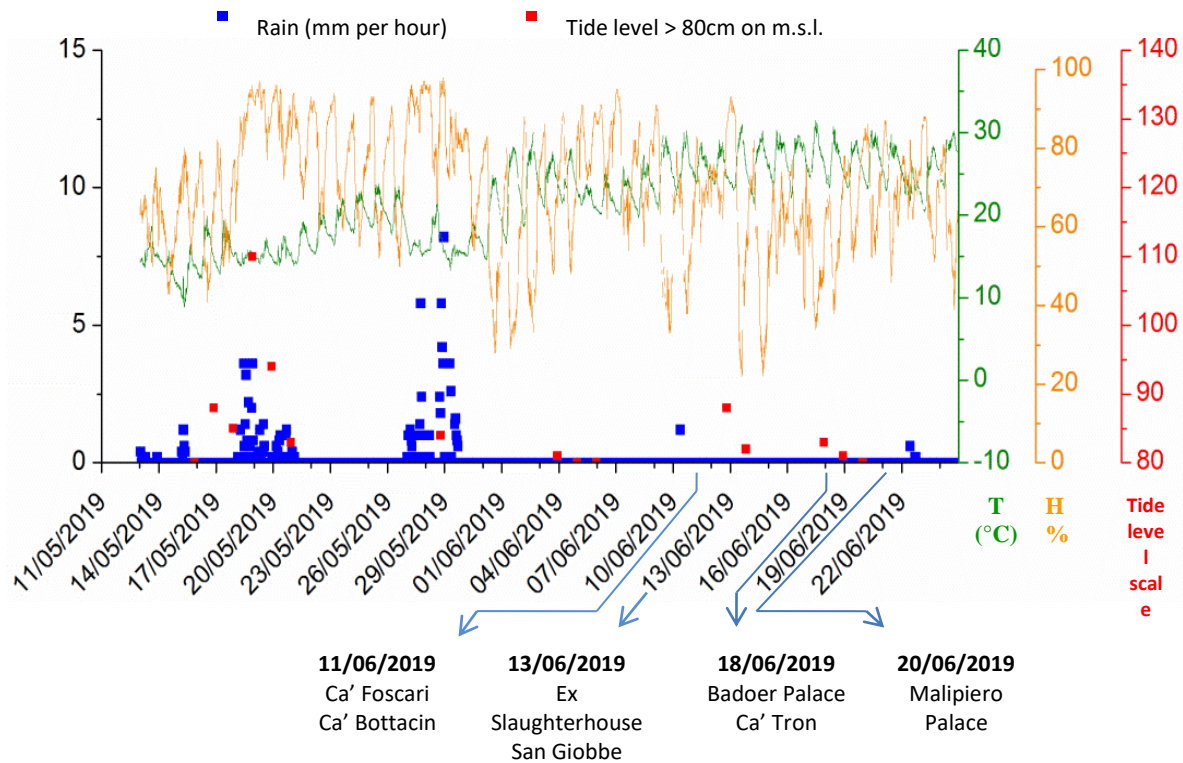
Figure 52 Weather and tidal information obtained from the Control Station at Cavalli Palace between 11th May and 22th June 2019 [20]. Temperature (T, °C), humidity (H%), rain and tide level with its scale are reported. The sampling date for the six analyzed buildings are specified.

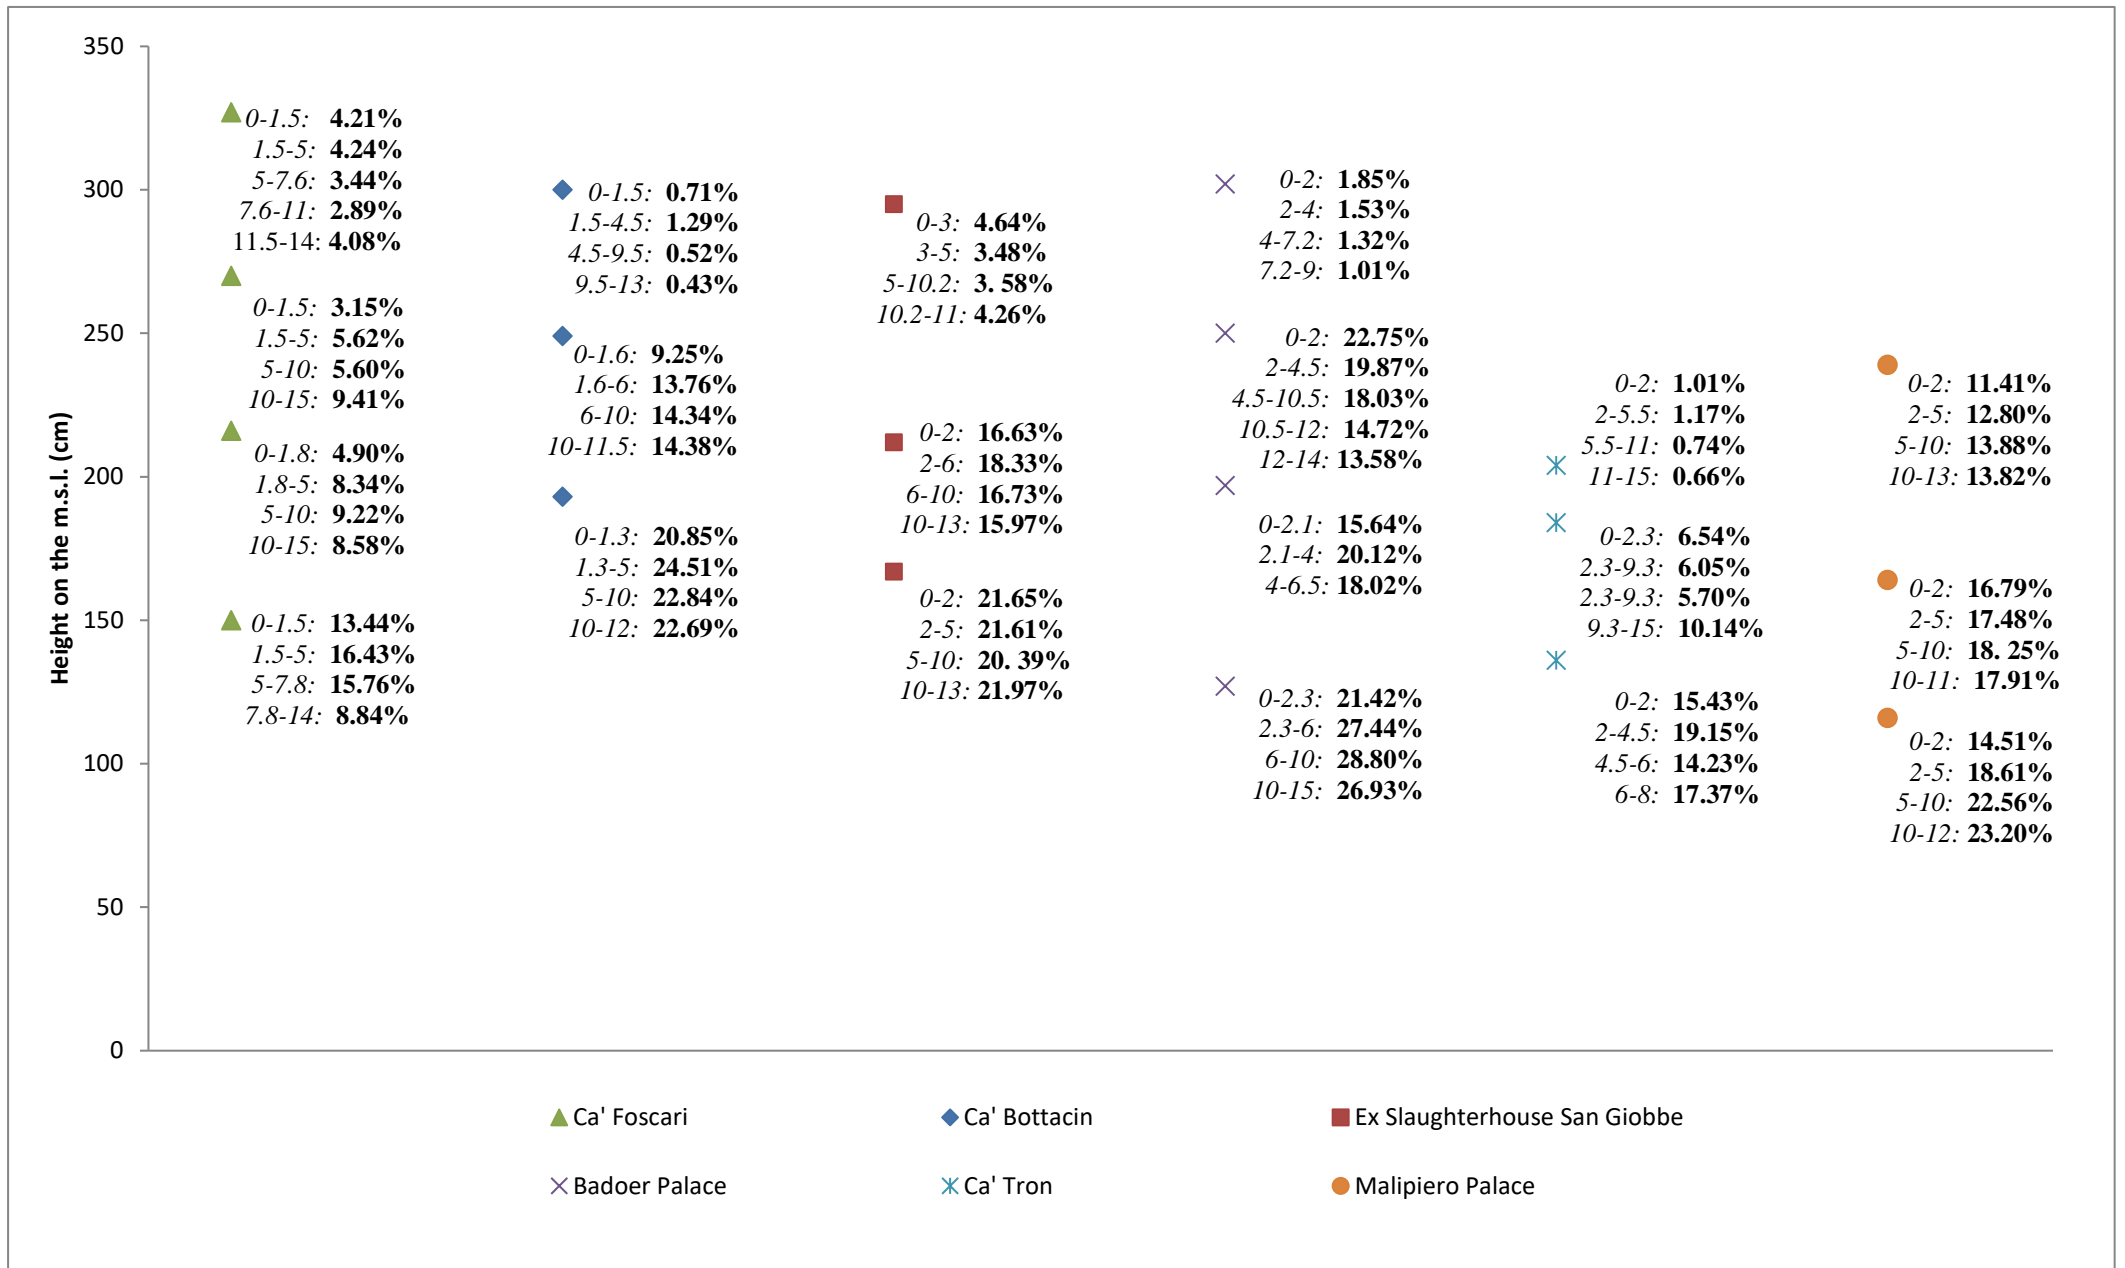
Figure 53 Comparison of Moisture Content percentage values for the six buildings, considering their height on m.s.l. and the respective samplings depths (all values are intended in cm).
