Ca' Foscari
University
of Venice

Final Thesis

Investigation of the rising damp phenomenon in
historical Venetian buildings by a new multi-
analytical approach

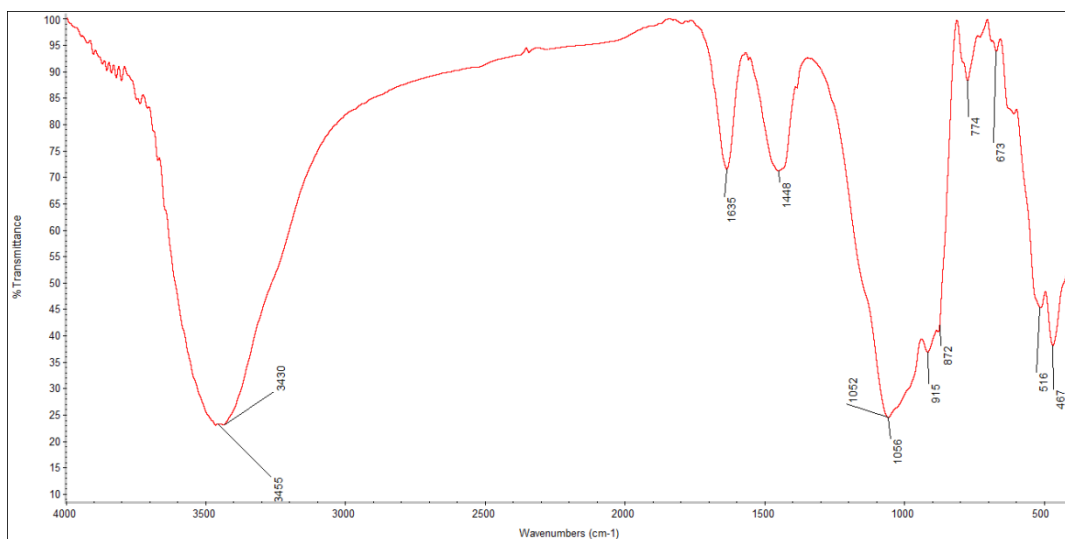
Figure 54 Infrared spectra of Ca' Foscari sample taken at 197 cm height from the ground (327 cm on m.s.l.) and 1.5-5 cm depth. The strong and narrow nitrates peak is clearly recognizable at 1380 cm^{-1} .

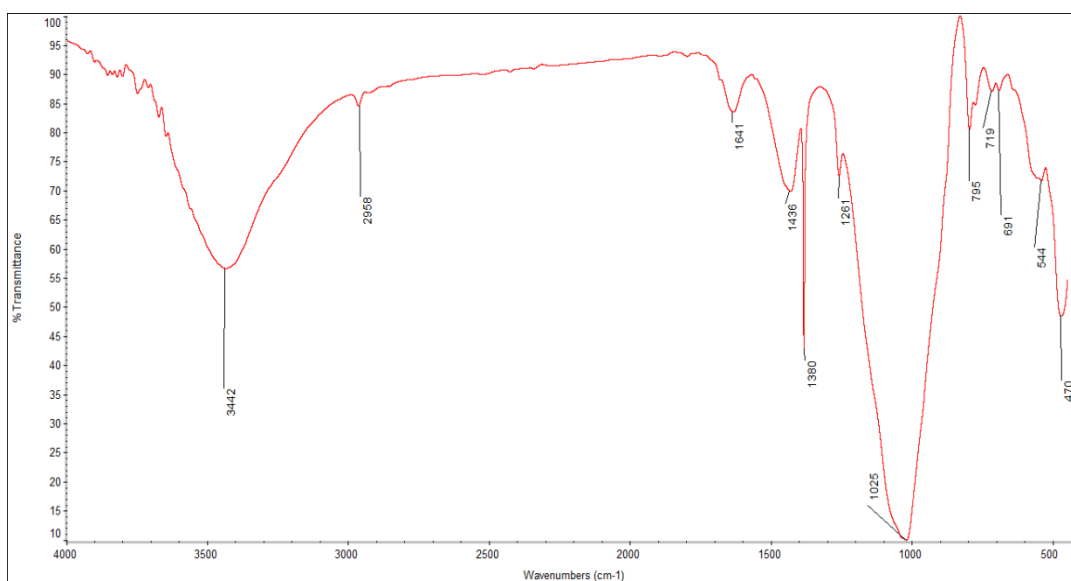
Figure 55 Infrared spectra of Malipero Palace sample taken at 149 cm height from the ground (239 cm on m.s.l.) and 2-5 cm depth. The nitrate peak is slightly visible.
